Seismic Review of Horowhenua District Council owned Buildings

Levin Memorial Hall

Concept Seismic Retrofit Scheme

Date: 6/06/2014
Reference: 5-P0523.01
Status: Final

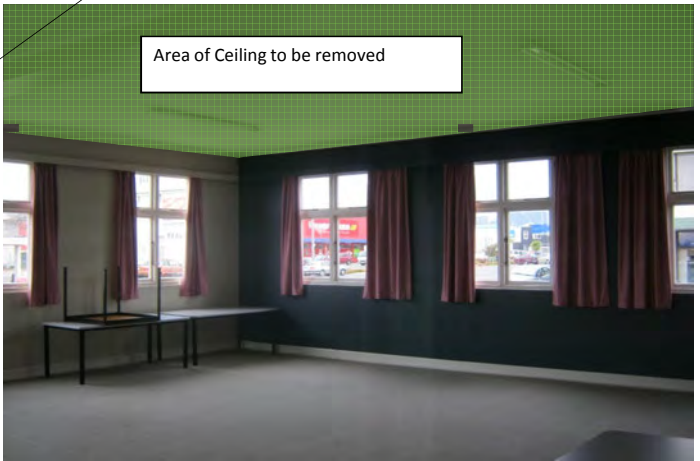
Steel Seismic Bracing Layout Sketch

As summarised above the proposed strengthening involves the addition of steel bracing above the ceiling level and the installation of a timber ceiling diaphragm in the Freyberg Room. The purpose of both aspects of the strengthening is to provide a load distributing system to prevent out of plane flexural failure of the reinforced concrete walls (longitudinal and transverse). The steel bracing in combination with the existing roof trusses creates a truss system that restrains the walls out of plane and to prevent excessive lateral deformation hence excessive flexural demands occurring at the base of the walls.

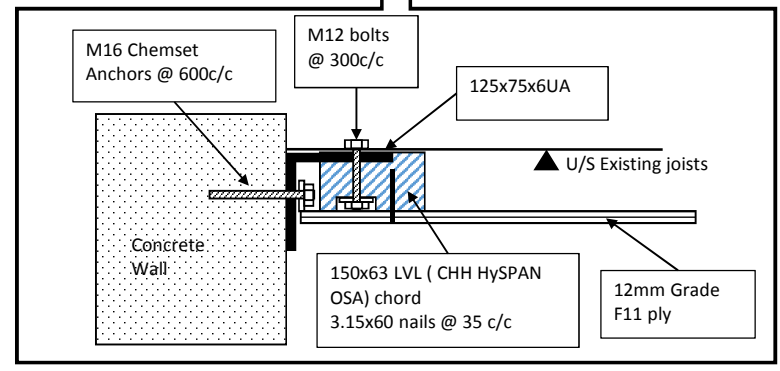
125x75x6UA around perimeter of diaphragm
 M16 anchors @ 600c/c chemset into concrete Wall.
 150x63mm LVL11 chords bolted to EA with M12 @ 300 c/c
